Western Washington University

Project Completion Report

Puget Sound Shore Erosion Protection Study

SHORE PROCESSES AND EROSION ABATEMENT ALTERNATIVES FOR PUGET SOUND

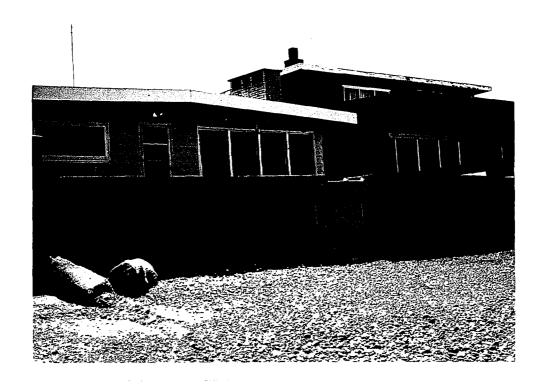
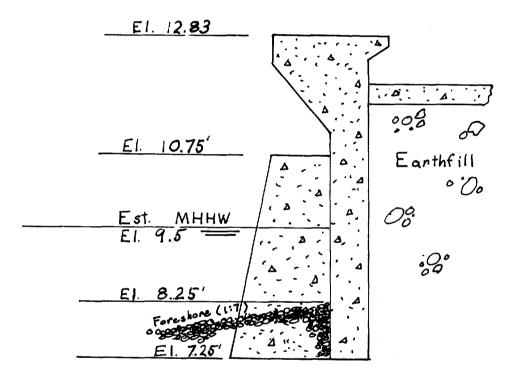
2. Structure Type: Concrete - vertical/recurved bulkhead

3. Location: Birch Bay, Whatcom County

This bulkhead appears adequately strong to resist the level of wave attack experienced at this site. There are no weepholes to provide drainage along the base of the structure, but since the backshore is impervious (concrete patio), none are needed. No tiebacks were incorporated in the bulkhead, a factor which could hasten overturning, should the beach lower more than 12 inches.

A 3-foot wide blanket of 20-50 pound rock at the toe would help to protect the footing from wave scour and reduce the possibility of bulk-head failure during a severe storm. Periodic placement of a fairly large quantity of sandy gravel at the bulkhead toe would also be a possible alternative should the beach lower more than 6 inches.

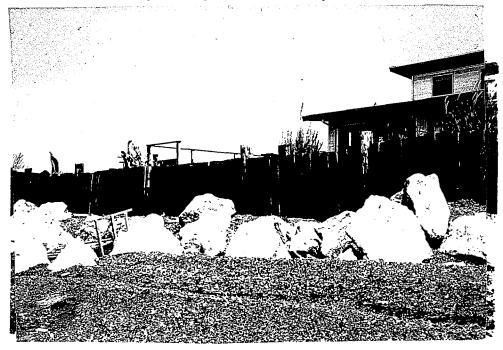
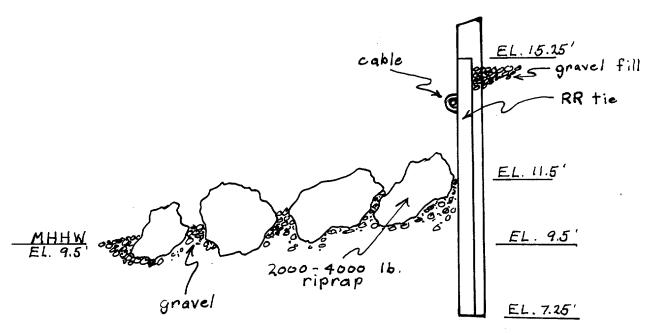
2. Structure Type: Vertical railroad tie bulkhead

3. Location: Sandy Point, Whatcom County

This bulkhead appears adequately strong to resist the normal level of wave attack experienced at this site. The riprap toe protection fronting the structure is adequate in size, but is subsiding because of a lack of proper bedding material. A horizontal cable which connects the railroad ties, probably lends little strength to the structure. Had tiebacks been attached to the cable every several feet, its usefulness would have been much improved. The bulkhead top elevation is sufficient to provide protection from wave overtopping and debris damage, except in the rare event of an exceptionally high tide occurring simultaneously with high winds from the northwest.

The structure could be improved by removing the existing riprap, placing an 18 inch thick by 8-foot wide blanket of quarry spalls (20-200

pounds) in front of the bulkhead, and then replacing the riprap on the blanket as close to the bulkhead as possible. This procedure would significantly reduct the rate of subsidence of the riprap. However, it should be noted that the recreational and scenic value of the beach has been lessened by the use of riprap.

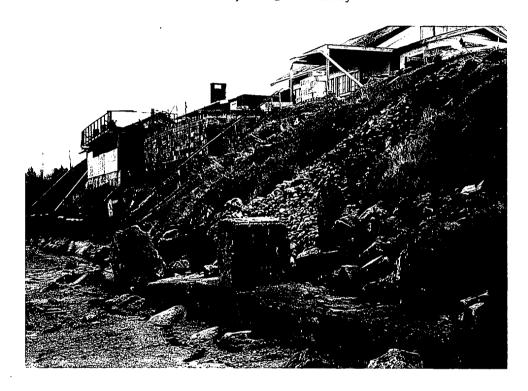
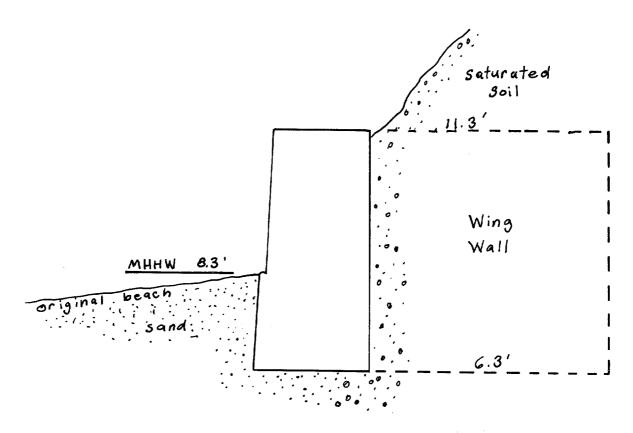
- 1. Structure Number: 3
- 2. Structure Type: Concrete - vertical bulkhead (failed)
- 3. Location: Samish Island, Skagit County

This site is exposed to wave attack primarily from the north. The net transport of beach material is from the northwest to the southeast, with eroding bluffs approximately 1/4 mile updrift of the site. Erosion of the beach appears to be a fairly slow process with the beach profile lowering at a rate of between 0.05 and 0.1 per year. This erosion contributed to, but does not appear to be, directly responsible for failure of this bulkhead. The primary cause for failure was probably the slumping of the bank which forced the bulkhead outward from behind.

This bulkhead, as originally constructed was adequately strong to resist the wave attack experienced at this site. However, the bulkhead was not a satisfactory bank retaining device. Lack of weep holes for drainage along the base of the bulkhead, compounded the bluff saturation problem. No tie-backs were incorporated in the original structure and the bulkhead had no rock toe protection. If toe protection or beach nourishment had been incorporated in the bulkhead maintenance, the 1-1/2-foot of toe scour which had occurred over the last 20 years could have been reduced. However, as discussed previously, toe scour is probably only a partial contributor to the problem. As constructed, the top elevation of this bulkhead was marginal. During extreme tides, there

was virtually no freeboard and any additional wave action probably caused overtopping, adding to the bluff saturation problem.

In this case, the lack of bank stabilization appears to be the primary cause of the bulkhead failure. If no solution is found for the bank foundation problem, the undestroyed portions of the bulkhead will probably fail in the near future. With no toe protection, the bank would be exposed to wave action, and the erosion rate could increase dramatically.

Solving the bank foundation problem could help to slow the rate of erosion at this site. Bank stabilization procedures could include resloping to a more stable angle, dewatering, and revegetation. In addition, a new means of protecting the bank toe should be provided. This could be a new bulkhead, either timber or concrete, or a revetment of some sort. In the event of further bank slumping, a "nonrigid" revetment of rock or gabions might prove less prone to catastrophic failure than a vertical bulkhead of wood or concrete.

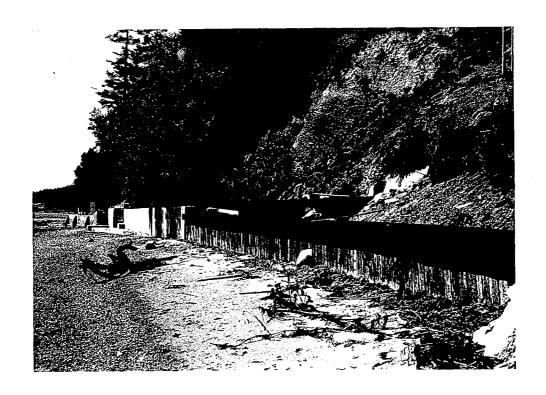
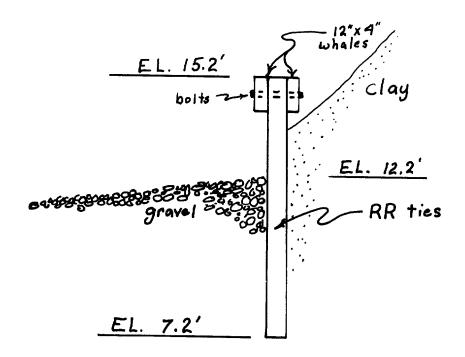
2. Structure Type: Railroad Tie - vertical bulkhead

3. Location: Fidalgo Island, Skagit County

This bulkhead is adequately strong to resist the level of wave attack experienced at this site, but the structure is not designed to retain the high bluff behind it. The structure top elevation appears to be adequate, but high tides accompanied by moderate wave action may produce some overtopping. Since no filter material was provided behind the structure, fine material eroding from the bluff may continue to pass through the bulkhead. As of the inspection date, toe protection rock has only been provided along the eastern 25 percent of the structure. This rock is adequately sized but protection of the entire toe should be completed promptly. No tiebacks were included in this design, but the structure is only four feet high and, may be adequately strong to support the back fill behind it. However, a major bluff failure would overturn the bulkhead whether or not tiebacks were used.

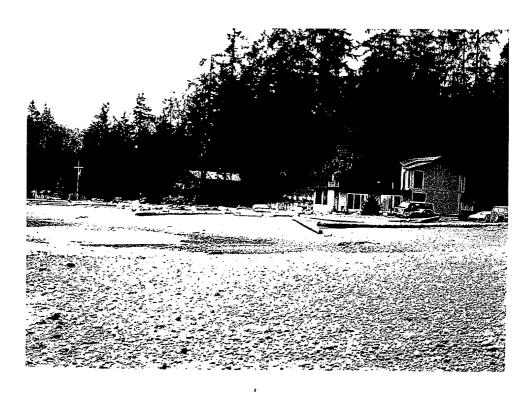
Bulkhead Site

- 1. Structure Number: 5
- 2. Proposed Structure Type: Concrete vertical/recurved bulkhead (proposed)
- 3. Location: Nisqually Reach, Thurston County

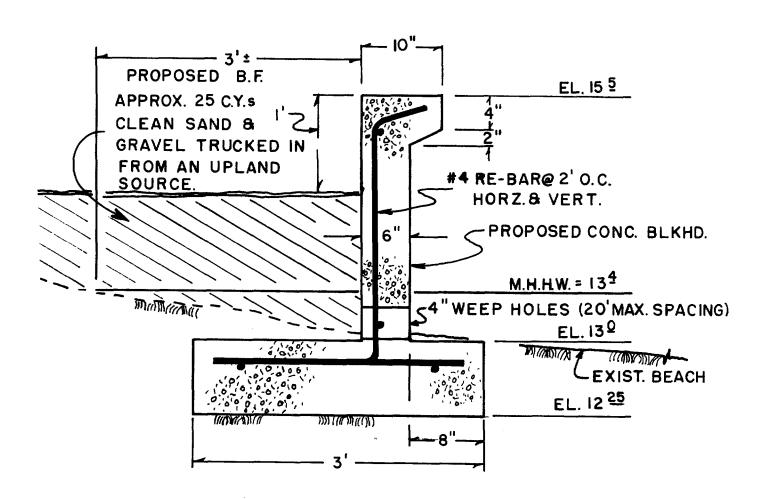
Proposed Design

The proposed bulkhead should be sufficiently strong for the wave climate at this site. However, the indicated bulkhead top elevation of 15.5 feet above mean lower low water (+15.5 mllw) is about 1.5 feet below the maximum estimated tide. At this elevation, the structure would probably be overtopped at least once annually. Since the proposed bulkhead does not completely enclose the backshore area and the foundation is extremely permeable, raising the top elevation by 1.5 feet or more would not insure that the backshore would remain dry. The plans for the proposed work show a backfill behind the bulkhead to an elevation of +14.5 mllw. This elevation probably will be surpassed by several tides each year. No toe protection is shown in the design plans, and without toe protection, the 9-inch deep footing is marginal.

This structure will probably do little to protect the backshore property from tidal flooding and could add to the problem by allowing the incoming tide into the backshore area and then retaining the water as the tide recedes. In addition, construction of the bulkhead may cause some increased erosion of the beach in the vicinity of the structure toe. The life of the bulkhead could be 20 years or more, depending on the toe scour rate and the degree of maintenance provided.

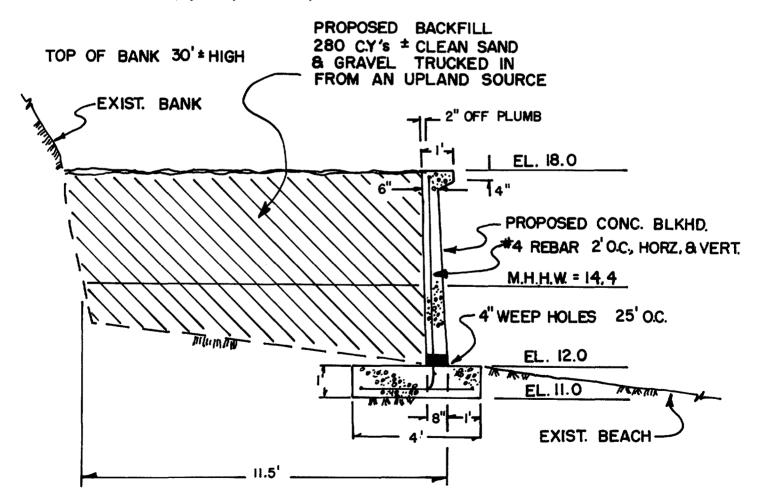
Proposed Design

The proposed bulkhead is sufficiently strong to resist waves which attack this site. The purpose of the bulkhead would be to retain the backfill material and additional bluff material which slumps onto the backfill and to prevent toe erosion. The top elevation of the bulkhead is satisfactory, but a footing depth of one foot may be marginal, particularly with no toe protection. No tiebacks are shown in the design, and with six feet of fill behind the structure, tiebacks may be desirable. The surface layer of beach material appears to be underlain by a clay-like material and attention should be paid to preparing a foundation for the bulkhead.

Two aspects of the geology and active geologic processes at this site relate to the design of any shore protection structures. A bulkhead could easily slide on the surface of the very hard impermeable silt underlying the gravels. Thus, it would need to be well "keyed" the silt surface but without disturbing it. Drainage would have to be carefully provided for as there would have to be no underflow. Secondly, superficial bank failure will continue but at a slower rate, even after construction. Thus, the bulkhead will need to perform some retaining wall functions as well as providing wave protection.

The life of this structure will depend primarily on its ability to resist overturning due to soil pressure. A high saturated bluff of clay and silt, and a clay-like foundation, will make the construction of a durable structure extremely difficult. Even if the bulkhead can resist overturning, the bluff will probably continue to slump until it reaches a stable slope.

- a. Use tiebacks
- b. Increase footing depth
- c. Provide toe protection
- d. Provide an adequate foundation

A riprap revetment is an alternative design which, if economically feasible, would be more flexible and might be less prone to catastrophic failure. Here again, foundation preparation would be critical. Another solution, if permits could be obtained, would be to construct an artificial beach of gravel and coarse sand. If graded to a 1:6 slope, such a beach fill would require about six cubic yards of material per foot of beach, in addition to the proposed backfill. This type of protection

would not be damaged by additional slumping of the bluff, and with periodic replenishment, would protect the bluff from wave action.

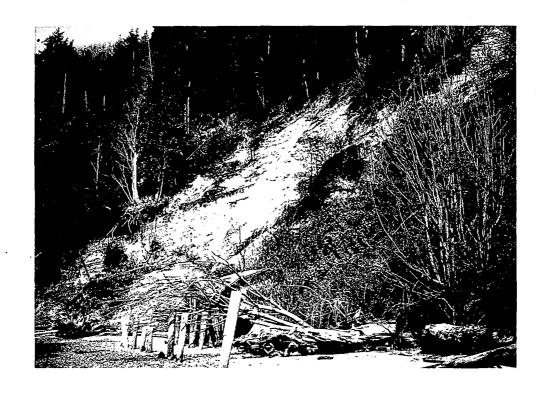
Erosion Site

2. Structure Type: None proposed as yet

3. Location: Tulalip Shores, Snohomish County

This site is exposed to heavy wave attack from the south. An effective fetch of about 6 miles allows the generation of waves in excess of 5 feet high. The relatively shallow beach probably causes the highest waves to break offshore, and waves striking the bluff toe should be limited to 3 to 4 feet under most conditions. The predominance of southerly waves causes the net transport of littoral material to be toward the northwest. Erosion problems at this site appear to be serious and seem to result from ground water activity in the bluff combined with wave action attacking the bluff toe. The bluff is over 100 feet high and appears to be composed of silt, clay, and sand. Material from the bluff is deposited at the bluff toe, then removed by wave action.

A bulkhead at this site may need special attention to its foundation design as the disturbed slide materials may well extend into the upper beach. As ancient landslides may reactivitate, every effort should be made to prevent groundwater buildup within the slide mass as well as the bank. Prevention of reactivation through drainage control will probably be much more effective and cheaper than a retaining structure.
